Eastern Connecticut Corridor Rail and Transit Feasibility Study (ECRTS)

Preliminary Feasibility Assessment
Appendix D: Thames River Corridor Assessment

March 2023

Prepared by AECOM Technical Services, Inc.

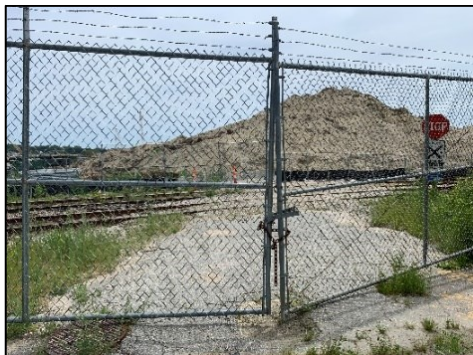
Figure 8: Thomas Griffin Road - Fenced Off Crossing with Private GC Sign

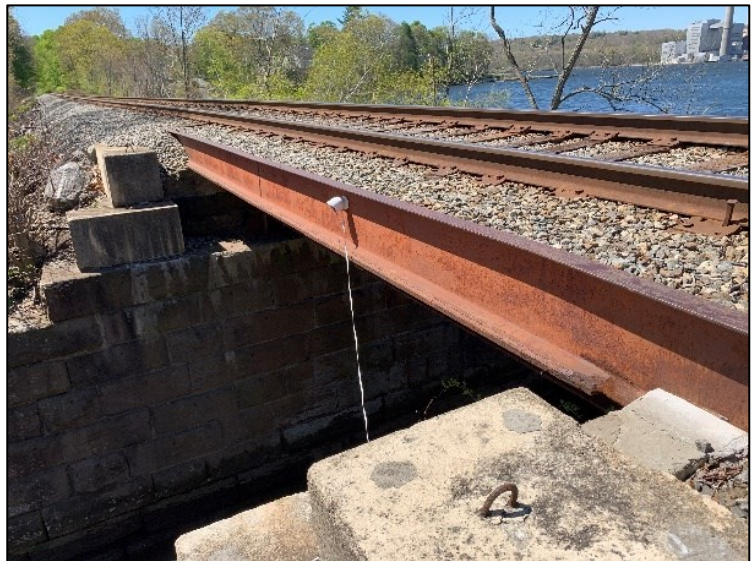
Ten (10) UG bridges combined along both corridors were defined as I-beam structures. Of the ten, two (2) received close visual inspections (MP 6.23 West Side and MP 5.11 East Side). Three (3) other structures received a limited visual inspection (MP 6.81 West Side / MP 6.79 and 7.09 East Side). The remaining five (5) were inaccessible due to inability to obtain visual inspection safely. Further inspection would be required that would authorize access to these locations to obtain an in-depth review of condition of these bridges.

Figure 17: I-Beam Bridge on Gales Ferry Marina (MP 5.11)

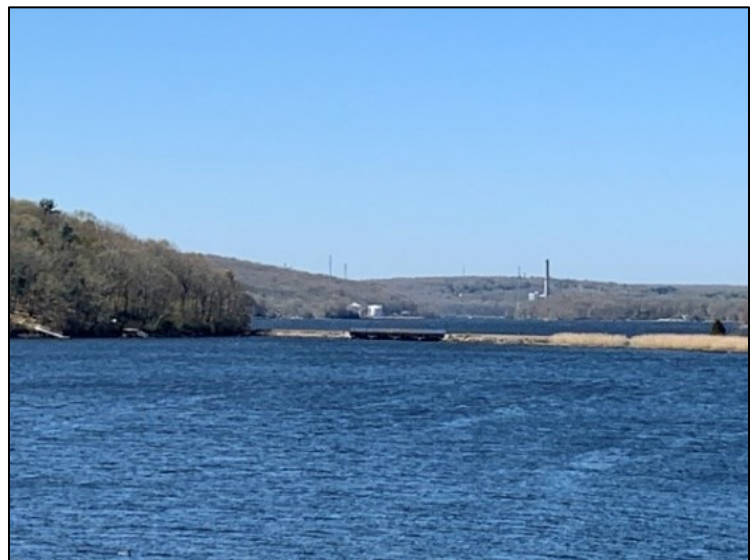
The inspection team observed one (1) bridge along the east corridor that was identified as a multi-span bridge. This bridge received a limited visual inspection (MP 7.83) and would require boat access to complete a full in-depth inspection.

Figure 18: Multi-Span Bridge on Poquetanock Cove (MP 7.83)

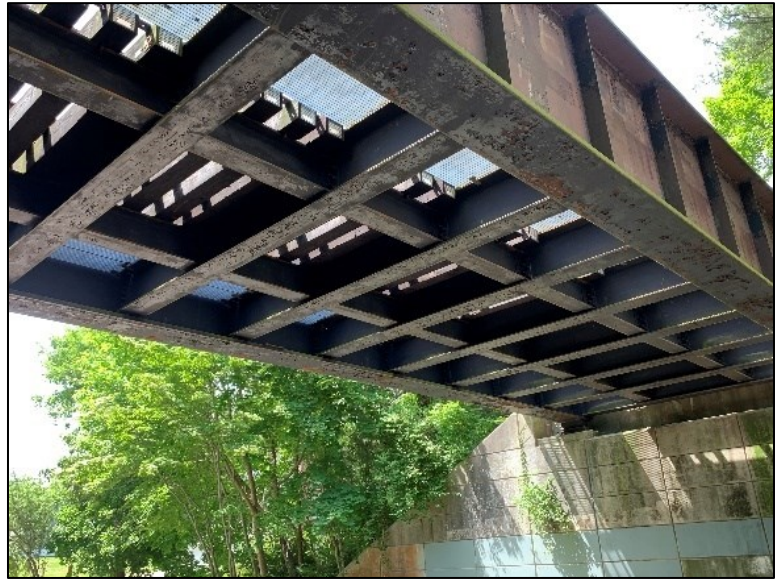
Nine (9) UG bridges were identified as Open Deck structures. Of these nine, only three (3) had visual access and that access was limited for two of them (MP 0.01 and MP 3.80 East Side). Bridge 504358R along the Groton Spur received a visual close-up inspection of the substructure and underside of the superstructure, but there was no access to the top side of the structure (MP 1.35). The remaining six (6) were inaccessible due to the inability to obtain visual inspection safely. Further inspection would require authorized access to these locations to conduct an in-depth review of condition.

Figure 19: Open Deck Bridge on Shennecossett Road (MP 1.35)

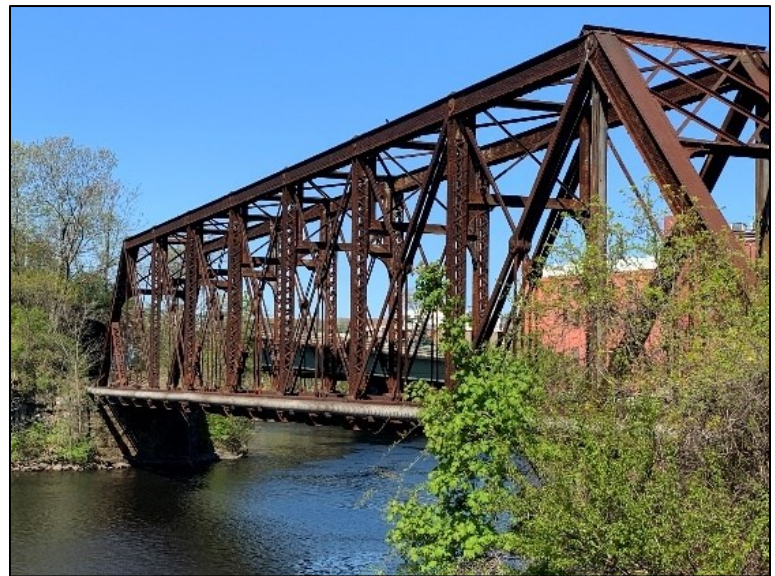
The inspection team observed one (1) Steel Truss bridge along the east corridor that was adjacent to the old Norwich Train Station. The team was able to get close to the deck and superstructure from the northbound side but was not able to obtain a visual on the substructure. Therefore, this bridge received a limited visual inspection (MP 12.14) and would require boat access to complete a full in-depth inspection.

Figure 20: Steel Truss Bridge at MP 12.14

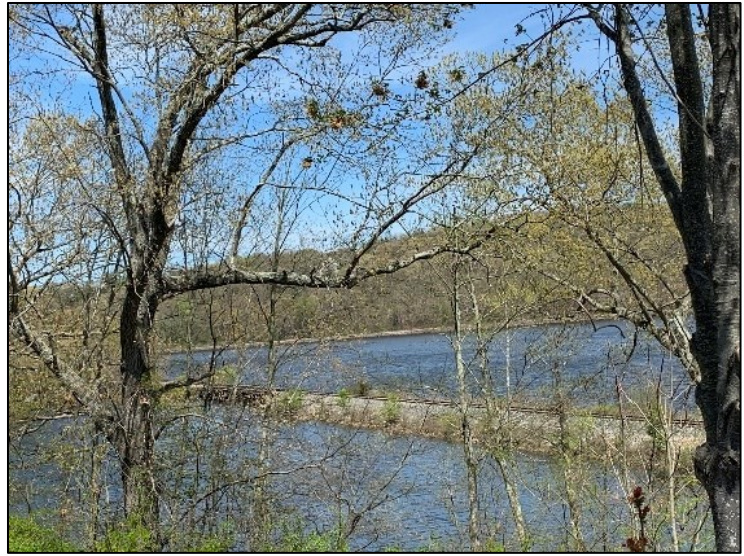
The inspection team observed two (2) Thru-Girders along the west corridor. One bridge was able to receive a limited visual inspection (MP 10.90) while one bridge was inaccessible due to the inability to obtain visual inspection safely (MP 7.47). Further inspection would require authorized access to these locations to obtain an in-depth review of condition of these bridges.

Figure 21: Thru-Girder Bridge at Trading Cove (MP 10.90)

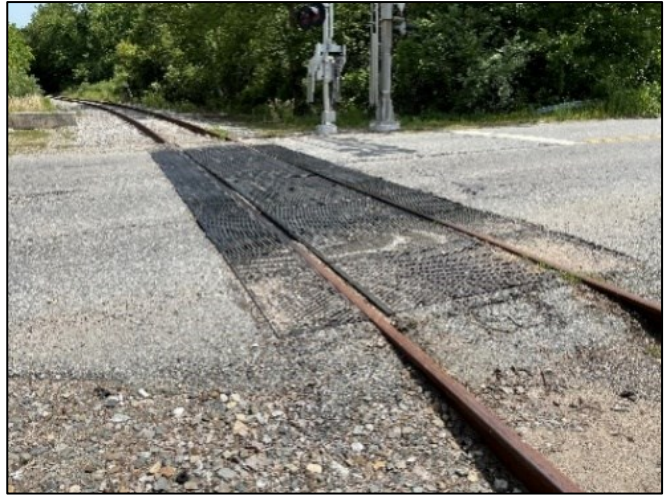
Rubber panels imbedded in the road were generally in good condition as they appeared to be installed recently and did not show any visual issues.

Figure 28: Benham Avenue Grade Crossing (MP 2.37)

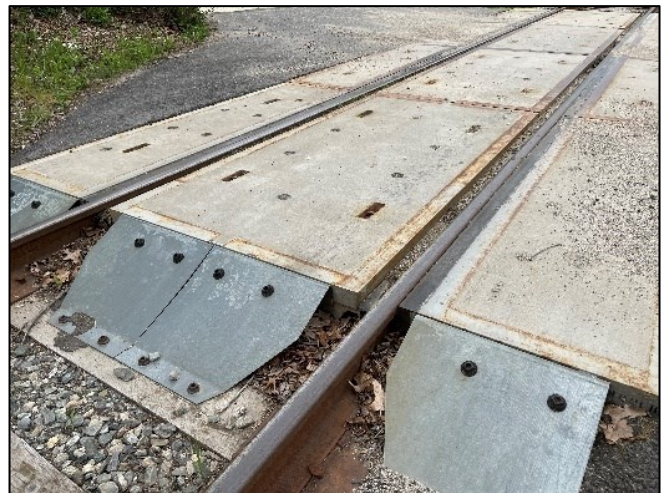
Pre-cast concrete panels were generally in excellent condition as they appeared to be installed recently and did not show any visual issues.

Figure 29: Point Breeze Grade Crossing (MP 6.50)

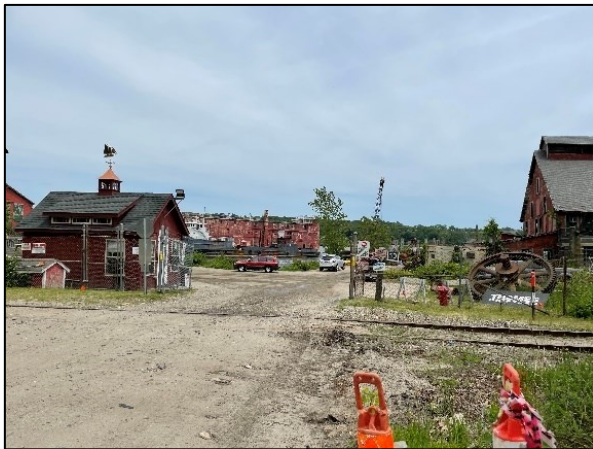
Figure 35: Old Thames River Shipyard (MP 1.79)

Several unpaved surfaces exist for private crossings and were not all able to be visually inspected. Any identified crossings with unpaved surfaces would need to be upgraded preferably to a rubber or pre-cast concrete panel crossing surface.

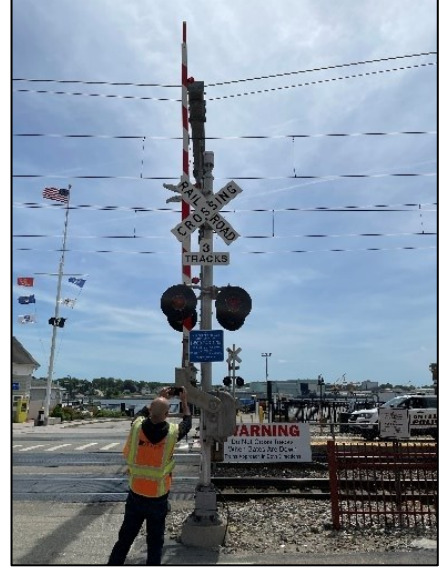
Few active grade crossings were identified to have a complete combination of bells, flashers, and gates. In general, it was presumed these control devices were in working condition, but further inspection will need to test these devices to ensure they are in proper order.

Figure 38: New London Train Station Grade Crossing (MP 122.76)

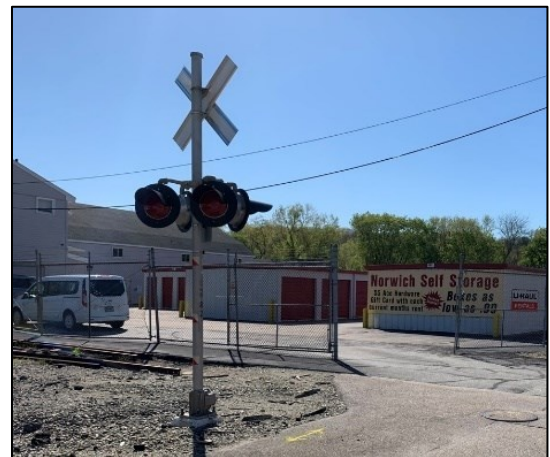
Figure 39: South Golden Street (MP 12.83)

Most active grade crossings observed tended to show flashers only adhered to a crossbuck signpost. In general, it was presumed these were in working condition, but would likely need to be updated to include bells and gates to support passenger rail service.

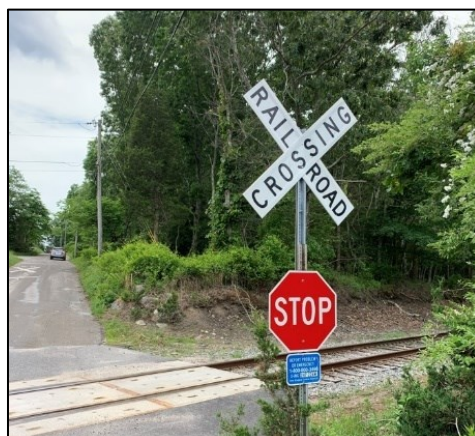
Figure 41: Point Breeze Road (MP 6.50)

Passive grade crossings that crossed over public roads generally had a crossbuck only sign. Only a few grade crossings identified in the field fit this category. Proposed passenger rail service would likely justify classifying these crossings as active and require a full upgrade of communication equipment to support bells, gates, and flashers.

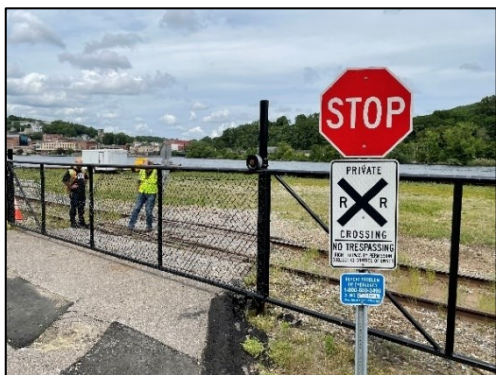
The most common occurrence observed in the field were private grade crossings that were either fenced or unfenced with a stop sign and private crossing sign.

Figure 43: Fenced Grade Crossing - South Thames Street (MP 13.00)

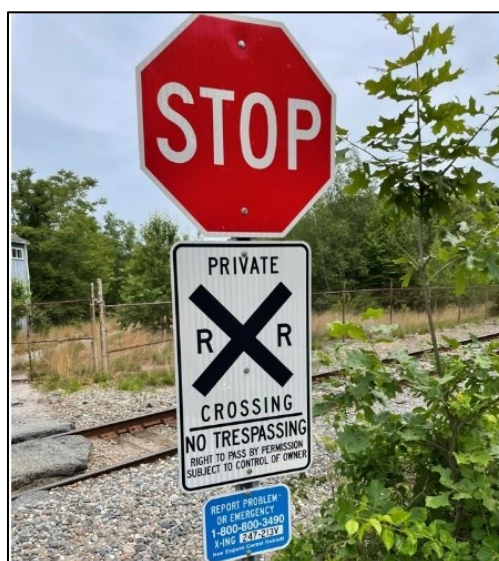
Figure 42: Unfenced Private Grade Crossing - Lower Bartlett Road (MP 5.05)

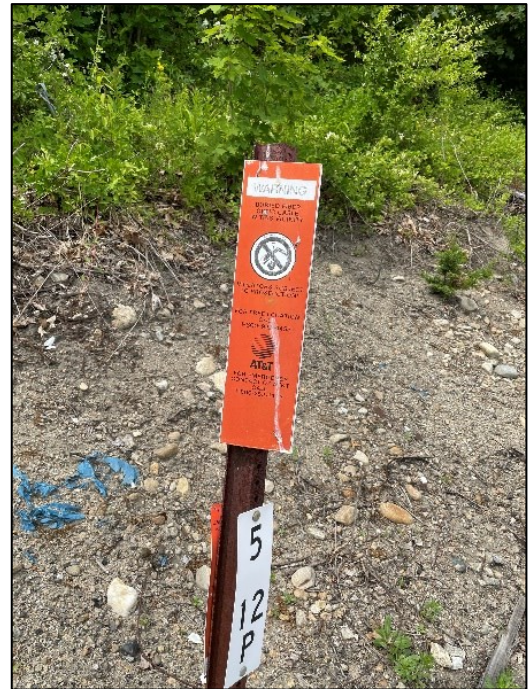
While out in the field, the team identified fiber optic cable warning posts along numerous grade crossings along the western corridor. This indicates that a portion of the corridor already has fiber, which potentially could be utilized for upgrading the communications infrastructure along the western side of the corridor. Further coordination would need to be scheduled with AT&T to determine what the existing fiber is used for, what utility conflicts could arise if the corridor needed to be rehabbed, and whether the rail corridor could tap into the existing fiber network to support its communication equipment.

Figure 44: Existing Fiber Optic Cable Warning Post (AT&T)

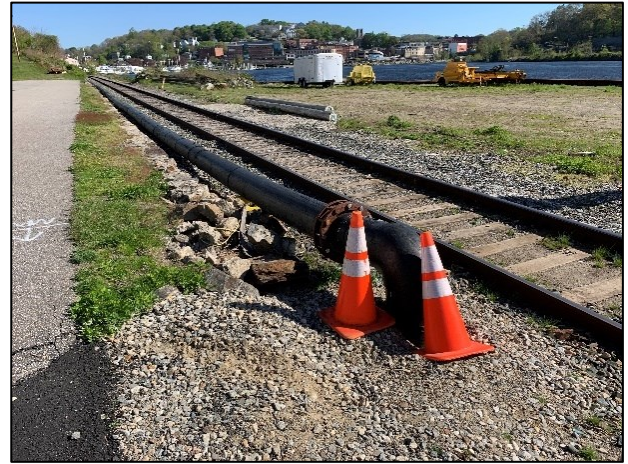
On various segments, the inspection team identified both underground and/or exposed sewage piping. In New London, the team noticed a sign for pipe-sewage with a depth of about 6 feet. In Norwich, the team identified an exposed pipe of approximately 12" in diameter, that is believed to be a temporary outlet for treated water from the Norwich Wastewater Plant. Further inspection will need to confirm where these utilities exist throughout each corridor, where the inlets and outlets officially go, and whether exposed pipes are temporary/permanent and what impacts they would have on ROW construction.

Figure 46: Exposed Outlet Sewage Pipe (Norwich)

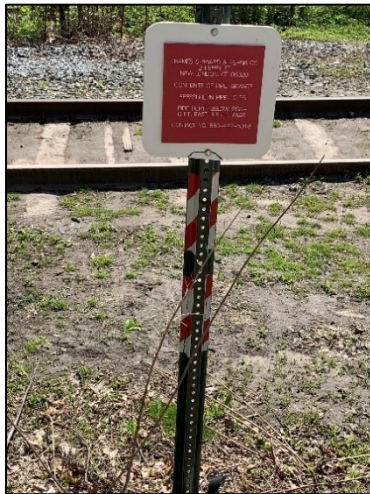
Figure 47: Signage for Buried Sewage Pipe (New London)

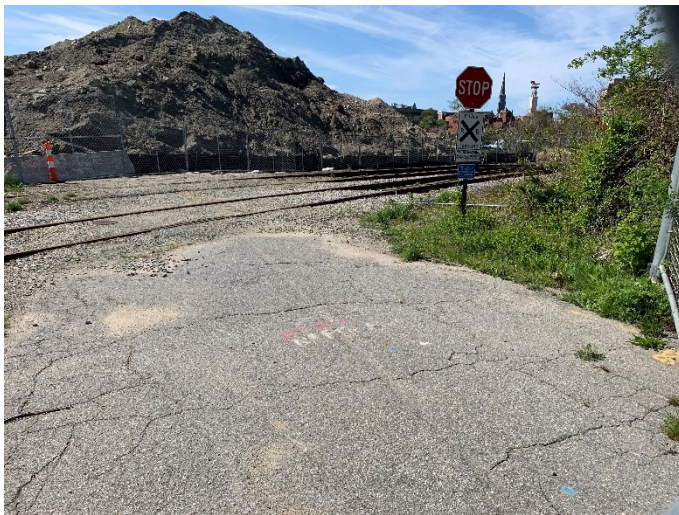
Figure 11: MP 0.40 – Grade Crossing - Thomas Griffin Road - Private Grade Crossing

Grade crossing on Thomas Griffin Road, just north of Timber Trestle bridge. Single track splits into double tracks right after crossing the timber trestle bridge. The crossing is gated off and not signaled. Site of Connecticut Port Authority is across the tracks.

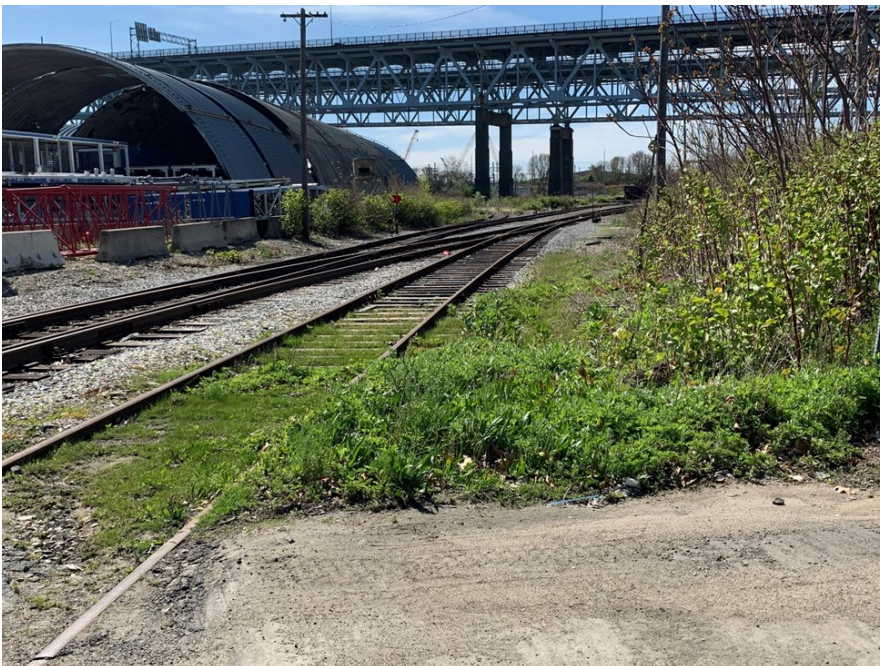
Figure 17: MP 0.91 - Grade Crossing - Eastern Avenue (Looking South)

Crossing is in poor condition and is not signaled. Vegetation growing in the gauge – sign of very poor drainage. Most likely, only one track is in active use.

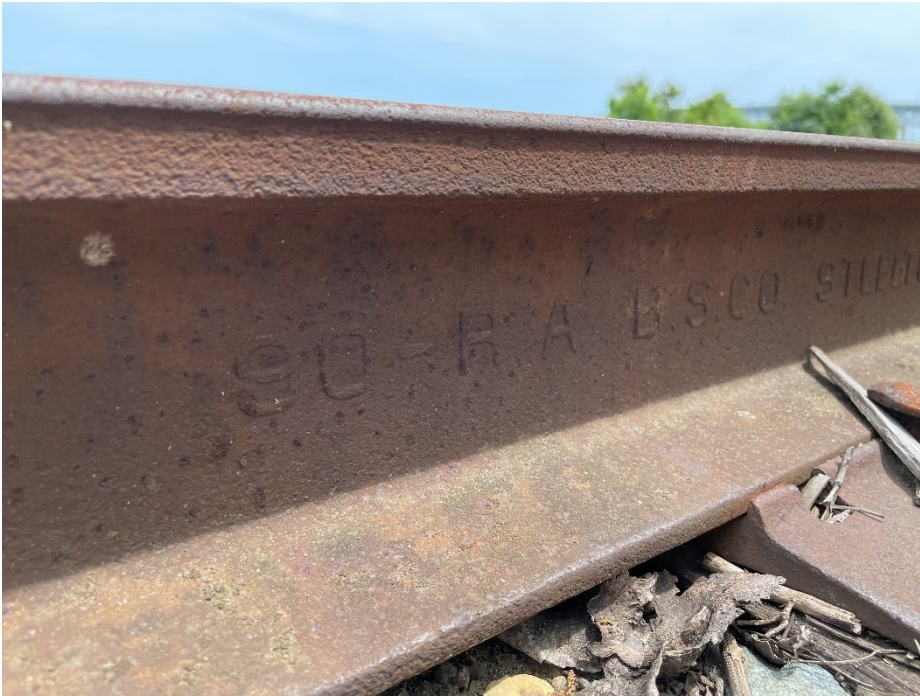
Figure 22: MP 1.07 – Track - Running Rail Weight Stamp - 90RA

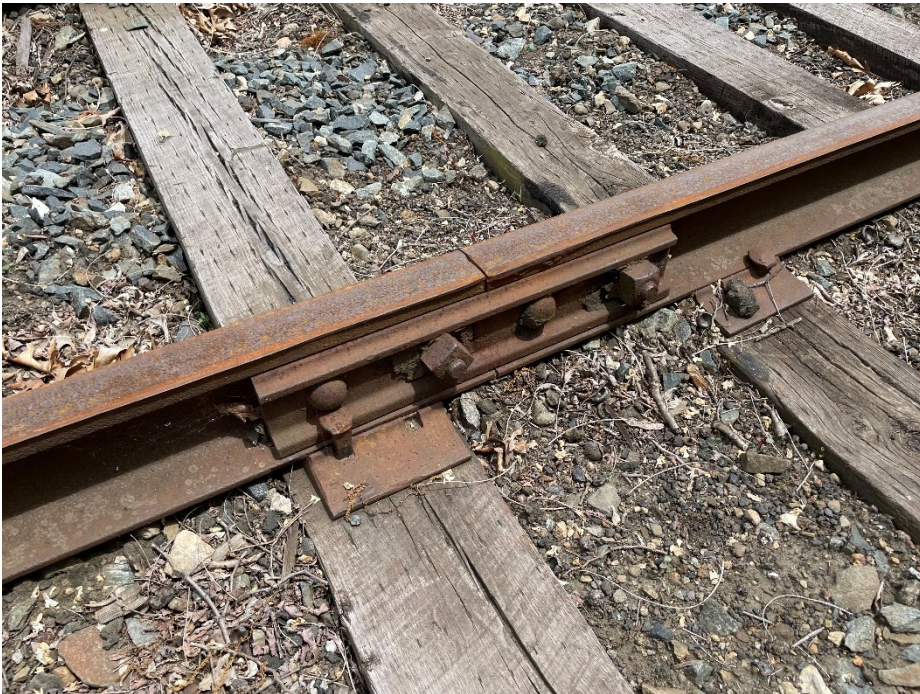
Figure 23: MP 1.07 – Track - Typical Rail Joint and Tie Condition

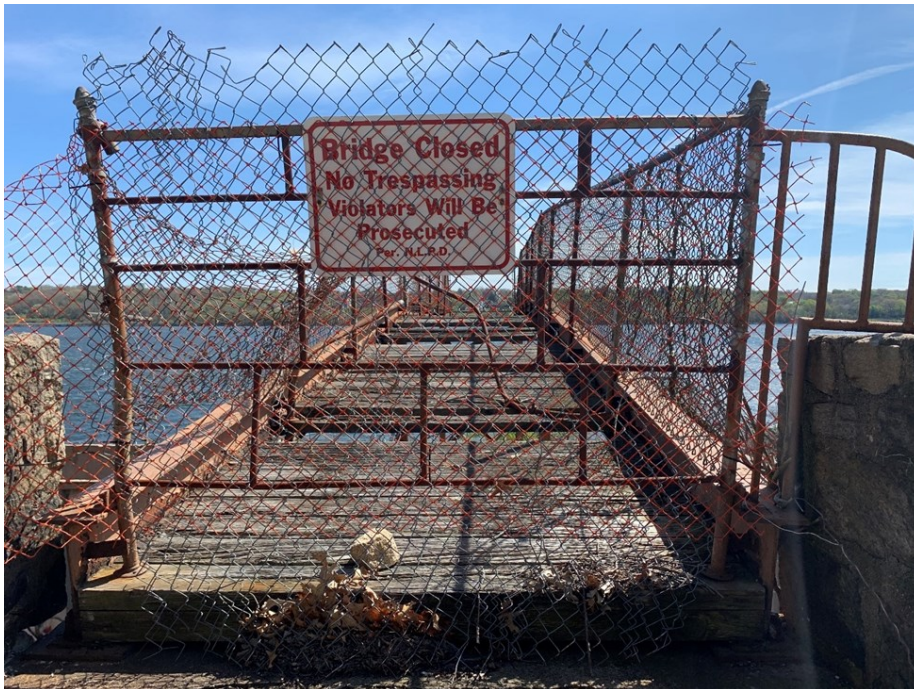
Figure 26: MP 1.07 – OH Bridge - Ped Bridge in Riverside Park (Looking East)

The bridge is closed due to its unsafe and unusable condition. Corrosion and missing timber boards. Some steel members have cross-sectional losses. The bridge would have to be removed to make the line safe for passenger service.

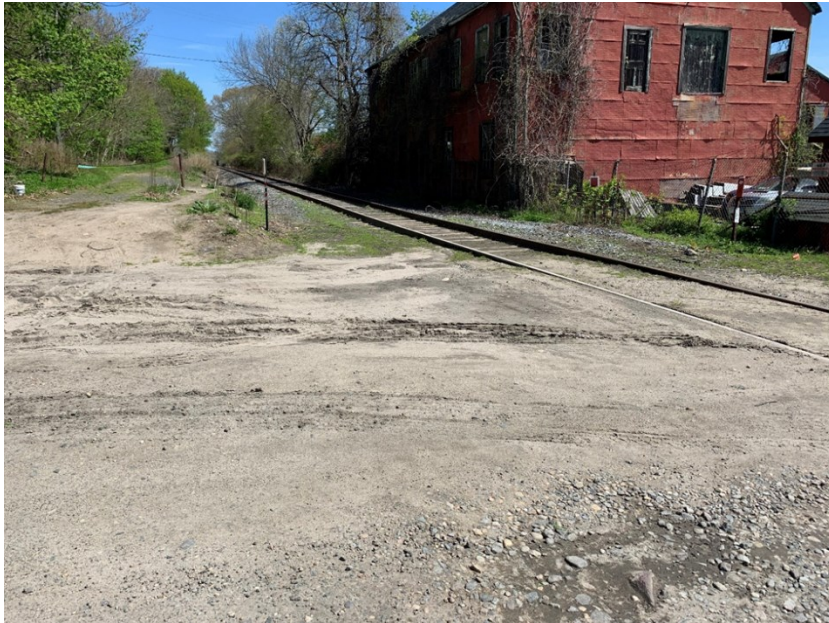
Figure 35: MP 1.79 - Grade Crossing - Farnsworth Street - Old Thames Shipyard

The crossing is covered with a lot of fine material from passing vehicles in and out of the shipyard – will need to be rebuilt with drains to the west of the crossing.

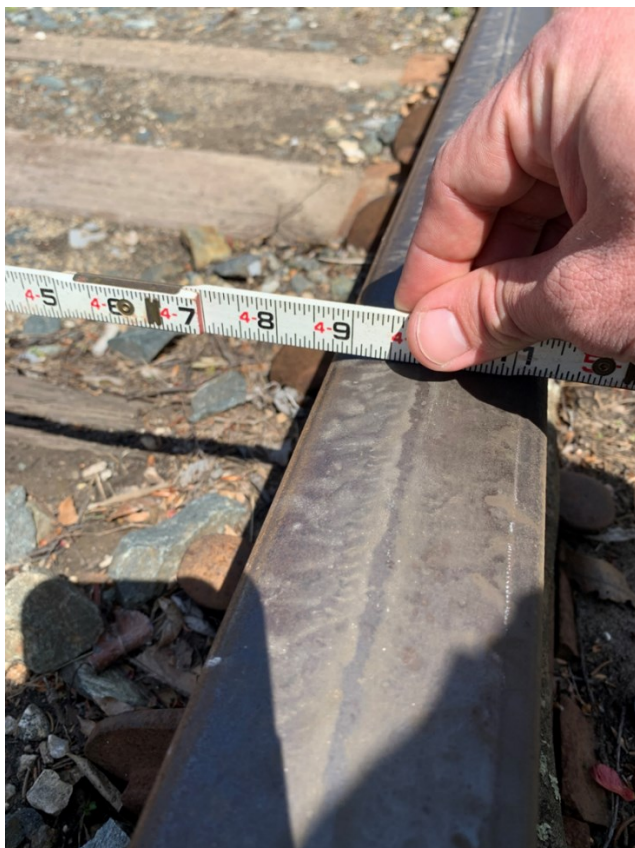
Figure 38: MP 2.37 – Track - Bentham Avenue – Measure of Track Gauge

Gauge dimension 4' - 8 $\frac{3}{4}$ " (1/4" off from the standard 4' - 8 $\frac{1}{2}$ " gauge)

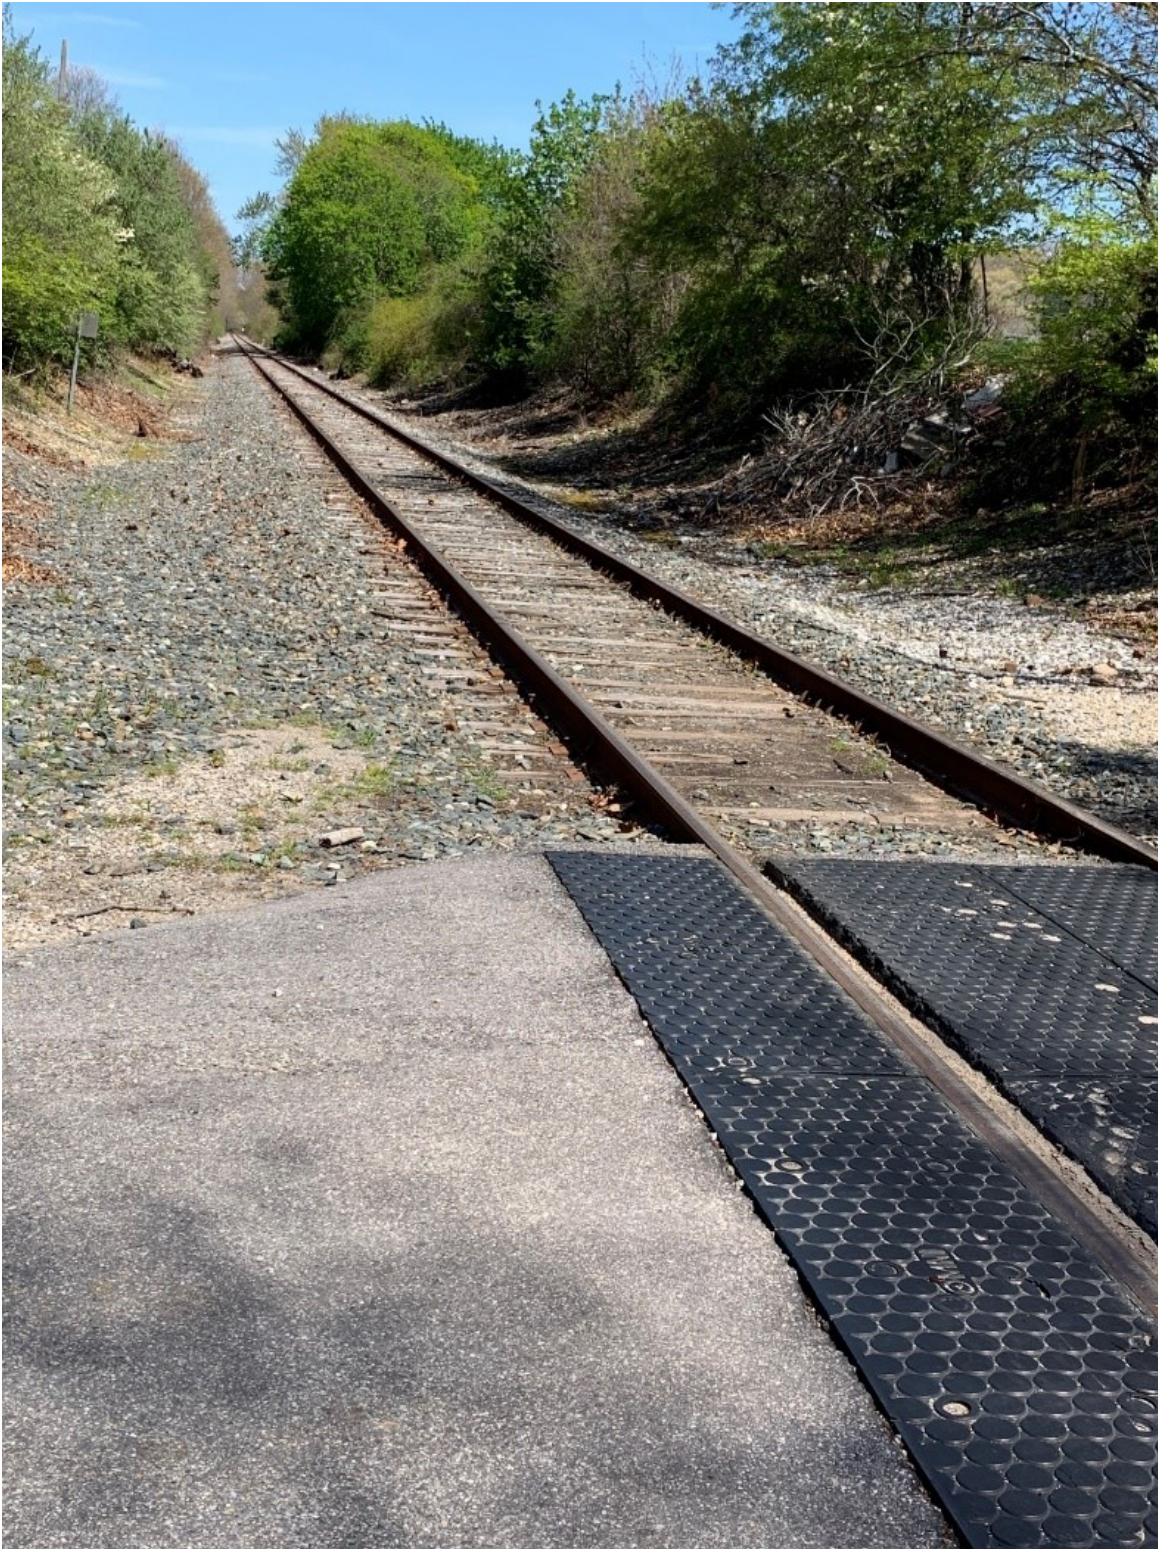
Figure 42: MP 2.37 - Grade Crossing - Bentham Avenue (Looking North)

Some vegetation in the gage and near the crossing. Proper drainage is needed.

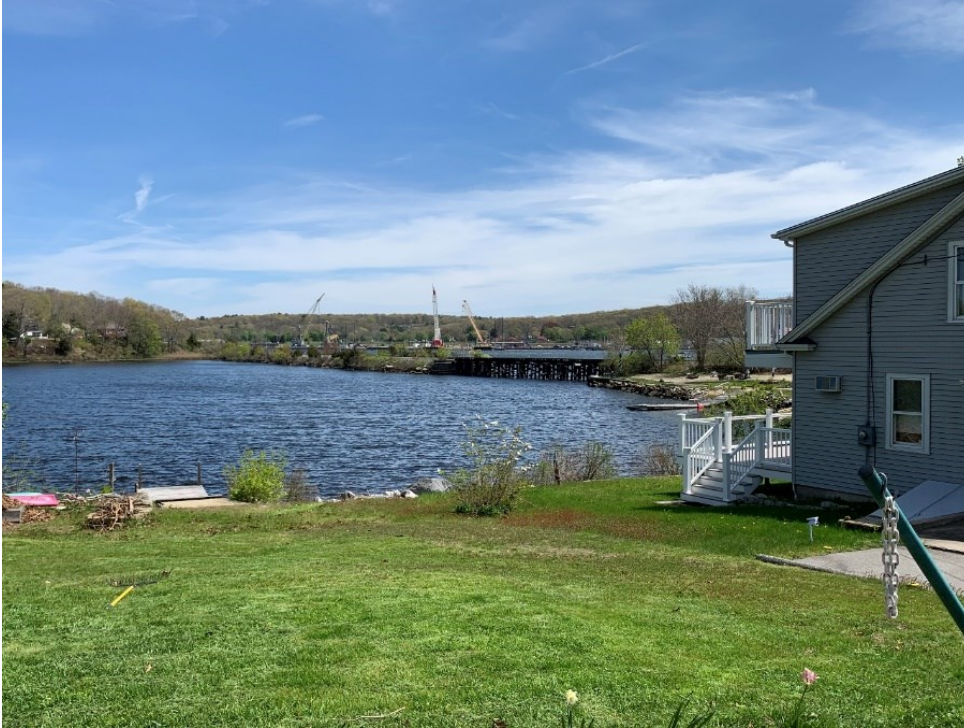
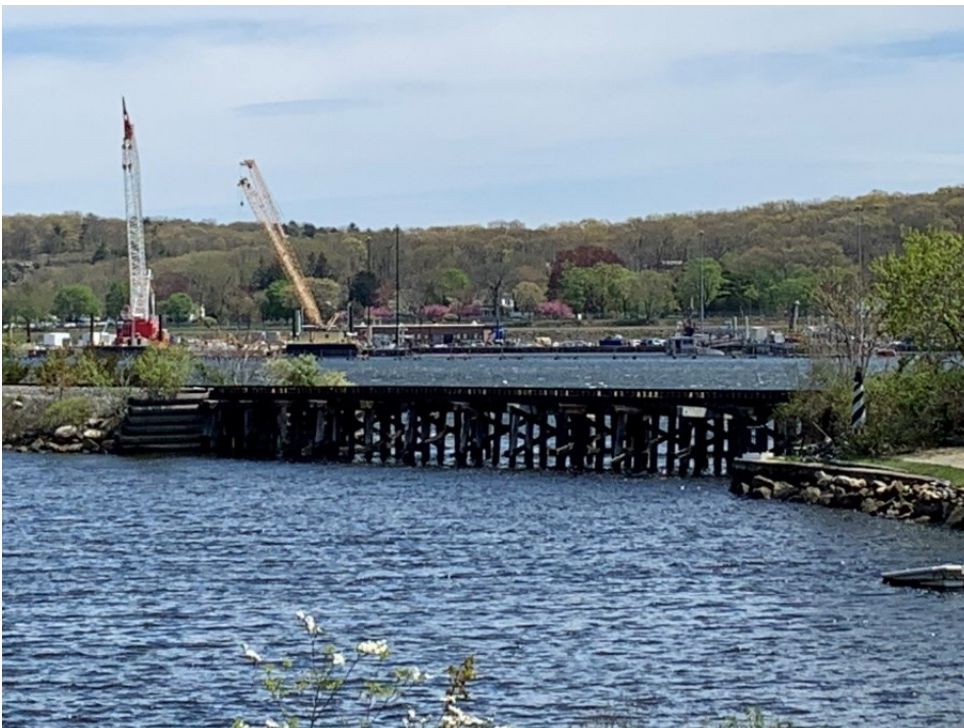
Figure 45: MP 3.25 – UG Bridge - Richards Grove Road - Timber Bridge - (Looking North)

Walking the right of way would be necessary to perform a closer inspection.

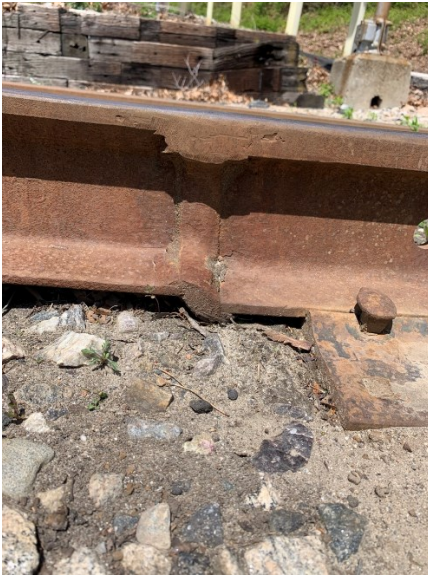
Figure 54: MP 5.76 - Track - Dock Road - CWR

Typical connection between 100 lb/yd rail and 115 lb/yd rail

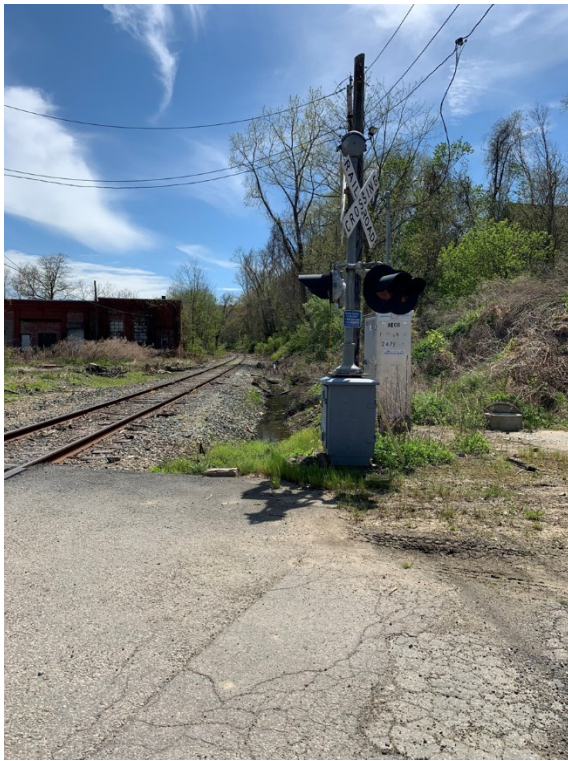
Figure 76: MP 11.90 – Grade Crossing - Terminal Way (Looking South)

Standing water and vegetation near the track – poor drainage.

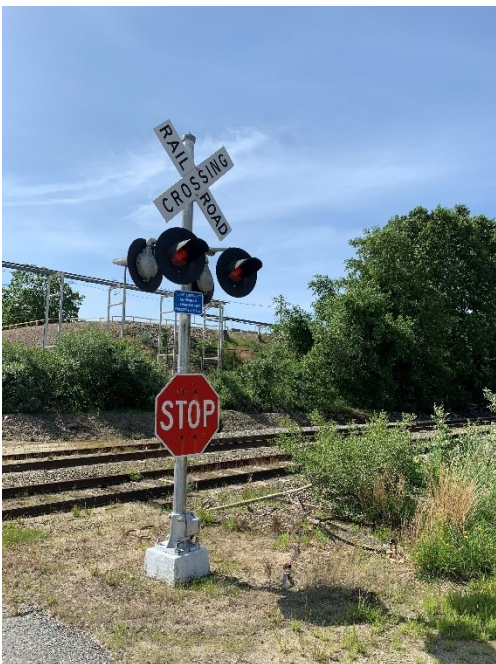
Figure 109: MP 6.08 - Grade Crossing - DOW Chemical

On google earth satellite view this area has a few industrial buildings and large storage tanks. Most likely, they were a part of the DOW Chemical plant. Currently the area has no buildings. It is also under an environmental clean-up operation according to the sign next to the gate. This area could be a potential location for a train station with a parking lot. However, a meeting with DOW Chemical would be necessary to see if they plan to construct a new set of buildings after the environmental clean-up is completed.

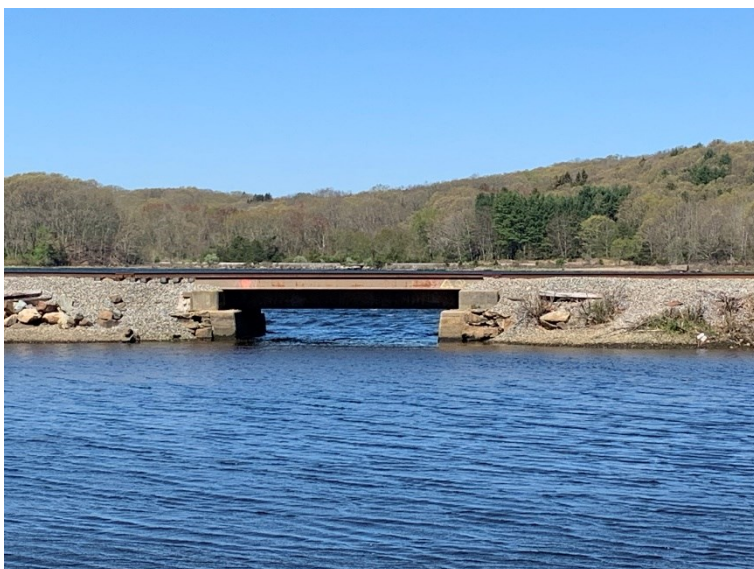
Figure 119: MP 7.09 - UG Bridge - Stoddard Cove

Track outage and/or flagmen are needed to walk on the right of way and perform an inspection.

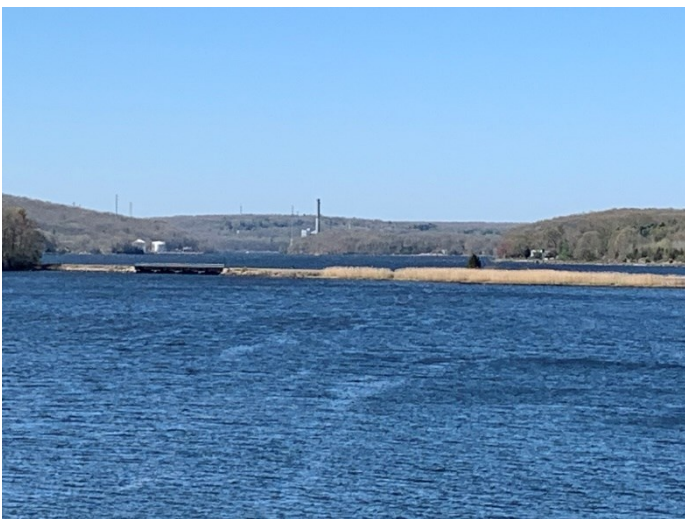
Figure 123: MP 7.83 - UG Bridge - Poquetanock Cove (No Access)

Track outage and/or flagmen are needed to walk on the right of way and perform an inspection.
